Preservation Committee Report -- May 21, 2026

Front Steps Masonry Repair

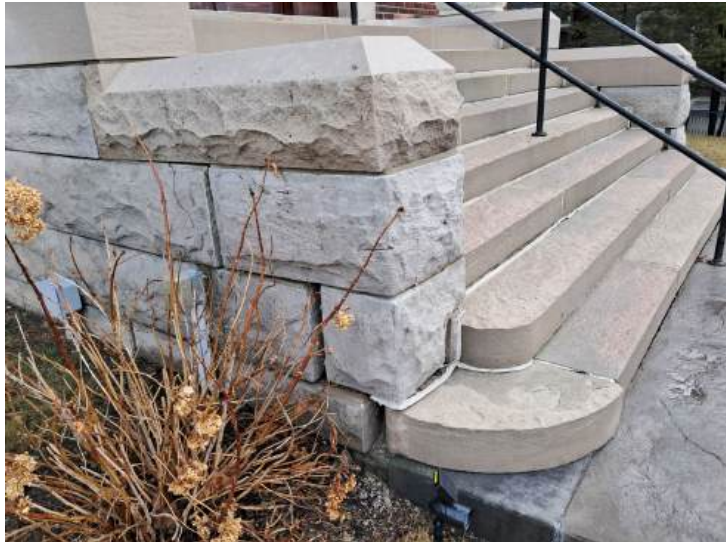
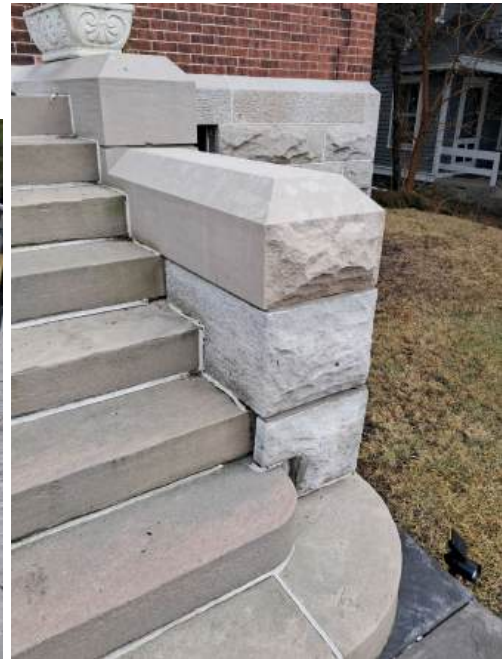
Before Repair

A masonry contractor from Skaneateles (Stock and Stone) has completed resetting and repointing the two stone balustrade side walls that had suffered frost-heave movement at the front steps to the Library. The work involved lifting the $\frac{3}{4}$ -ton cap stone, removing the underlying stonework, repairing the partially disintegrated cinder block footer, and resetting the stones in proper position, followed by careful re-pointing all mortar joints. They also re-pointed some failed joints in the building foundation beneath the two front cellar windows. Next in line, they will return to seal the front stone steps to prevent future water entry.

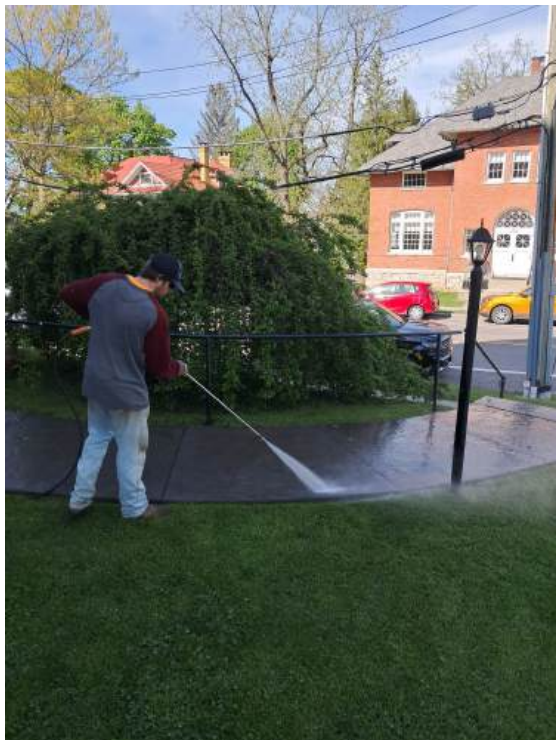
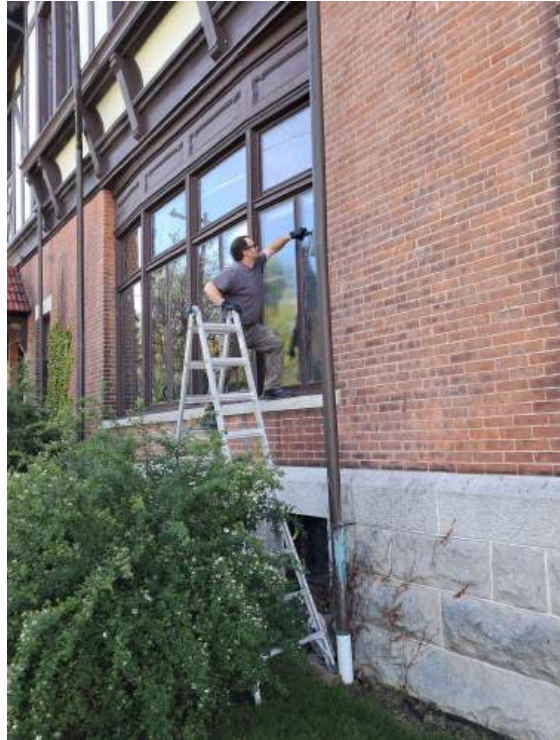
On May 16, Andy Fayette of Proper Wash LLC from Aurelius washed all windows on the main floor and power sprayed exposed masonry, including the side and front steps and walkways. Bird droppings begone!
